# Virginia Department of Forestry BMP Effort, Implementation, and Effectiveness Field Audit

November 2002

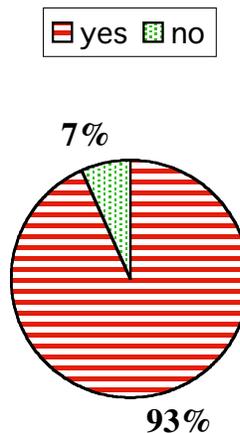
Efforts to implement BMPs were evident at 93% of inspected timber harvests, matching the 93% recorded in June 2002, (*fig.1*). Quality of effort, rated on a scale of 1(poor) to 5(excellent), averaged 2.9, slightly lower than the average of 3.2 in June 2002. Implementation of all necessary BMPs to DOF standards occurred at 7% of

Fig. 1: Has An Effort Been Made To Apply BMPs, Regardless Of Meeting Technical Specifications?

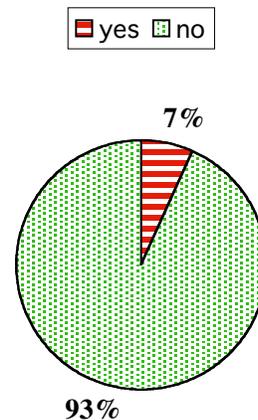
inspected sites; down from a 27% BMP implementation rate recorded in June 2002, (*fig. 2*).

Fig. 2: Were All BMPs Applied To Technical Specifications As Expressed In The BMP Manual?

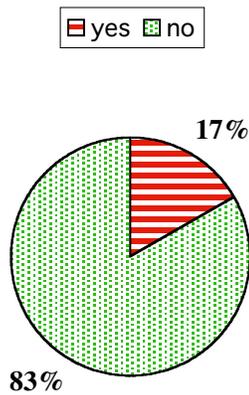
Active sedimentation existed at 17% of the inspected sites; up from 7% in June 2002, (*fig. 3*). The potential for sedimentation was noted at 10% of the inspected sites, down from 13% in June 2002, (*fig. 4*).

**Fig. 3: Does Active Sedimentation Exist Now Because BMP Technical Specifications Were Not Met?**

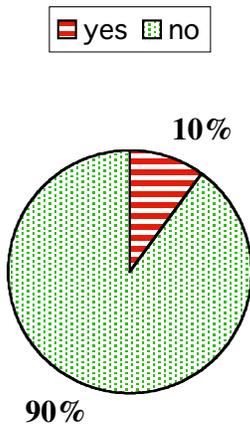
**Fig. 4: Does The Potential Exist For Active Sedimentation To Develop Because BMP Technical Specifications Were Not Met?**

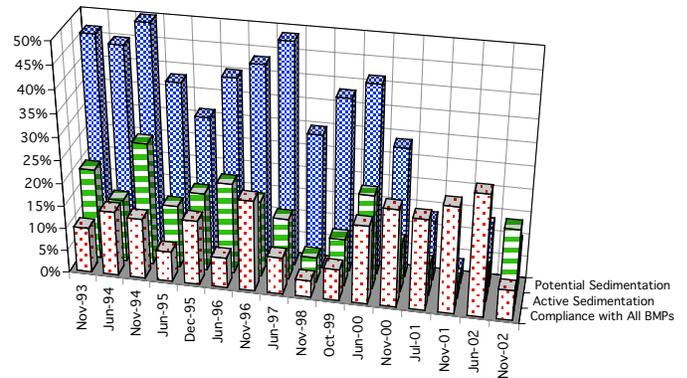
**Fig. 5: Three Trends**
